# H2Obvious®

**LEAK DETECTION**

**CORROSION UNDER  
INSULATION - CUI**

## H2Obvious For CUI Mitigation

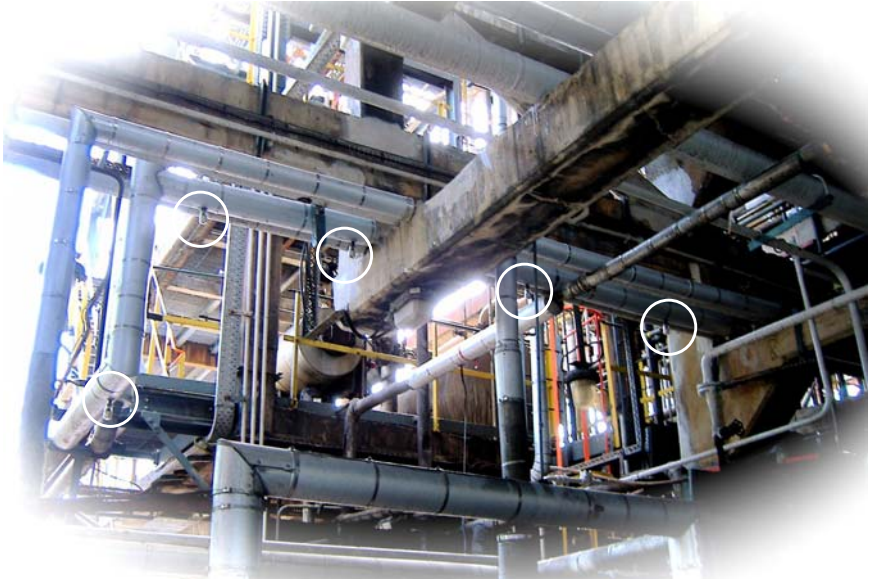
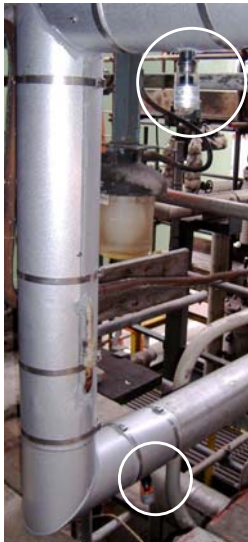
**H2Obvious installed at 1 metre (3 feet) intervals along the horizontal and at the base of the vertical**  
*(Circled below)*

*"This pipe rack has a prolific history of corrosion under insulation (CUI)"*

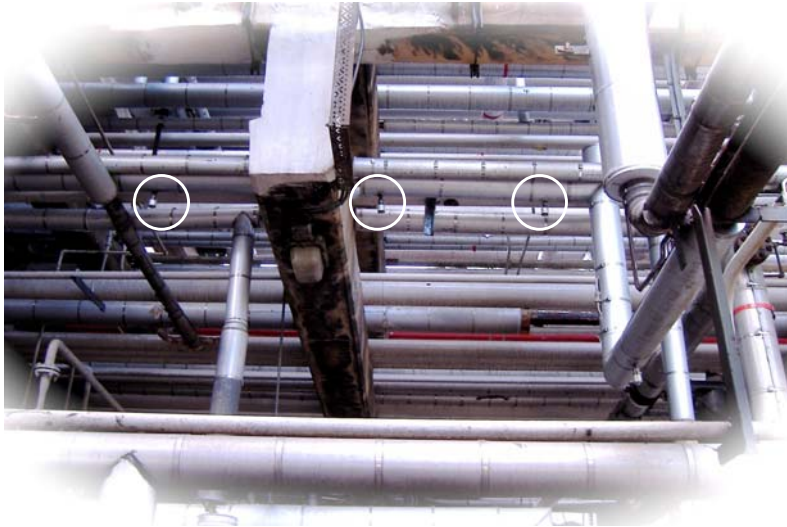
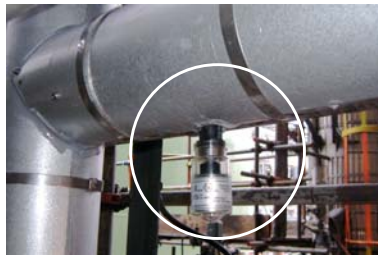
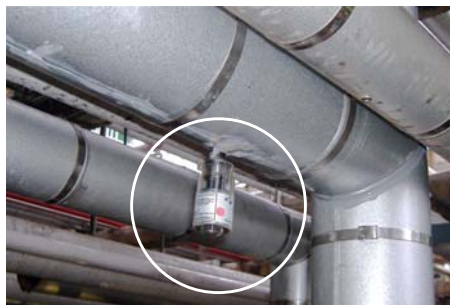
Re-insulated process lines utilising H2Obvious for fluid monitoring, installed at each insulation media joint

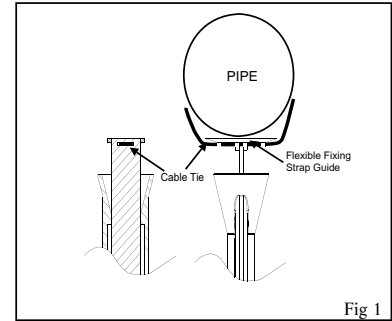
Fig 1

Take funnel and fit a flexible fixing strap guide, smooth side up with its slot co-incident with the slot in the strut. Thread a suitable fixing strap through the slot and loosely fix it round the pipe (Fig 1), ensuring that the strap lies between the raised features on the strap guide. Slide the assembly up to the edge of the insulation. The funnel must hang vertically with the threaded end facing down.

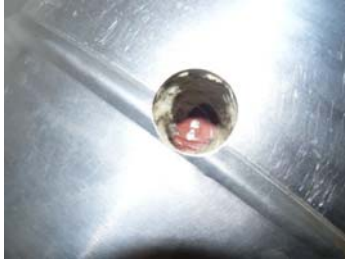
Bored Hole at the 6 O'clock position exposing bare pipe surface

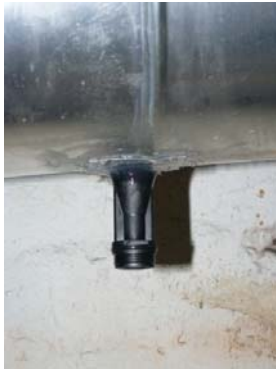
Collector Funnel secured in place using a standard silicon sealant

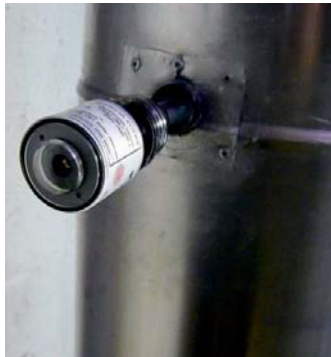
Additional plate to secure the funnel, H2Obvious unit/phial screwed into place (Not essential)

- 7, Ensure you hold the base of the collector funnel with one hand whilst screwing on the H2Obvious vial/unit to the base of the funnel. Always make sure that the ‘O’ ring seal is engaged when screwing in place the H2Obvious vial/unit (You will feel resistance and a squeak when fully engaged)

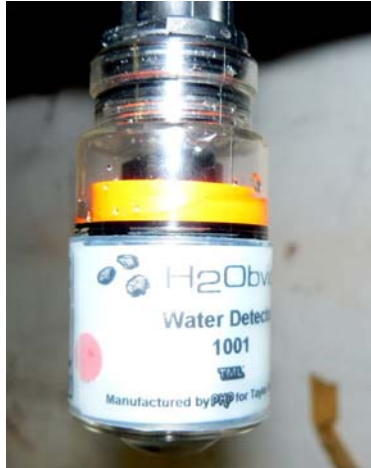
H2Obvious detecting and activating the presence of fluid on the pipe surface under the insulation

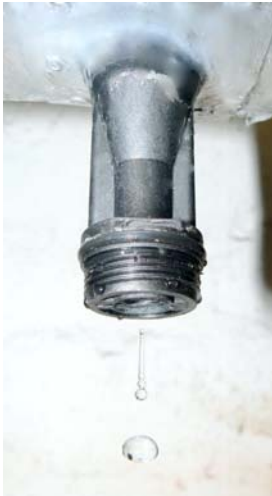
This picture clearly shows fluid exiting the collector funnel from within the insulated pipe

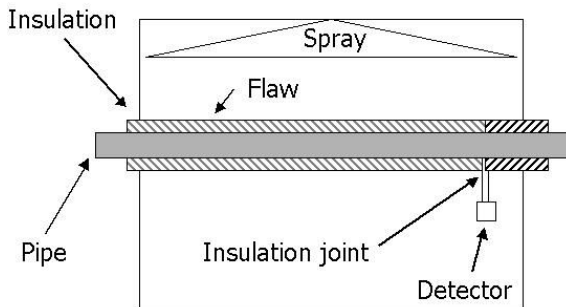
The H2Obvious detector device was fitted at a joint in the insulation. Deliberate flaws were made through the top of the cladding at 0.8 m distance to the detector. Slits were cut in the System 2000 and Ultrashield. In the case of the metal cladding, one 25mm diameter hole was made in the sheath. The pipe was angled slightly with the detector at the low end.

Schematic diagram of test set-up

Artificial seawater (ASTM D1141) was used for spraying. Two air-mist nozzles produced a continuous fine spray, similar to a dense fog or fine drizzle. All surfaces, including those not in the direct line of spray, were wetted. The nominal spray rate was approximately 1.5 cm depth per 24 hours, and was measured daily by a collection funnel.

The detector activated on the 45<sup>th</sup> day of the test. Moisture was visible inside the detector collection chamber, but not sufficient to lift the float.

The outside of the insulation and inside of the sheath was wetted, and there was some penetration through the rockwool towards the pipe, particularly at the joints. The pipe itself was entirely dry with no evidence of moisture having been present (for example, fresh corrosion).
